**INSTRUMENTATION APPENDIX TO  
PERIODIC INSPECTION REPORT NO. 5  
KNIGHTVILLE DAM, MASSACHUSETTS**

**Haley & Aldrich, Inc.  
Cambridge, Massachusetts**

**File No. 11163-006  
July 1995**

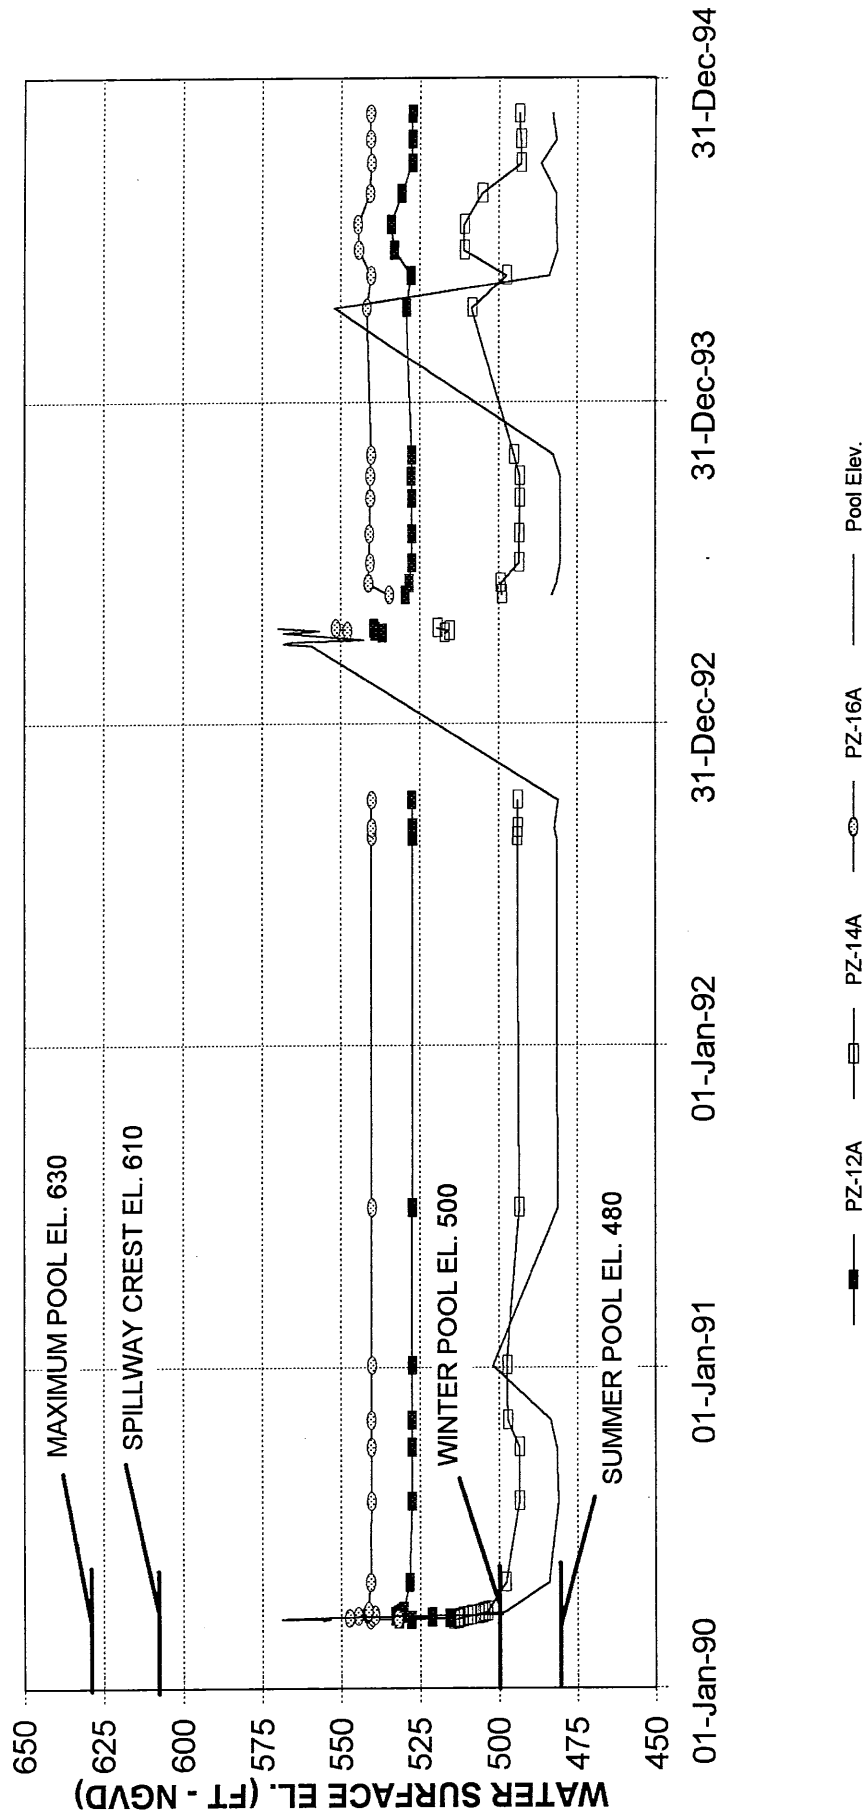
FIGURE 21

Based on the March 1990 flood event shown in Figure 21, the following performance was noted. Measurements for 22 and 23 March show an unusual drop in the piezometric level. These

Based on the March 1990 flood event shown in Figure 21, the following performance was noted. The water level in PZ-14A rose from its average level about 10 ft. to El. 513.2 compared to a pool increase of 69 ft. to El. 568.8. The pool data available for the March 1990 event indicates a peak pool level on 21 March and a falling pool through 29 March. PZ-14A water levels fell from a peak level on 21 March to lower levels through 29 March. The peak water level at PZ-14A apparently occurred on 21 March; therefore, it appears the response time was less than one day.

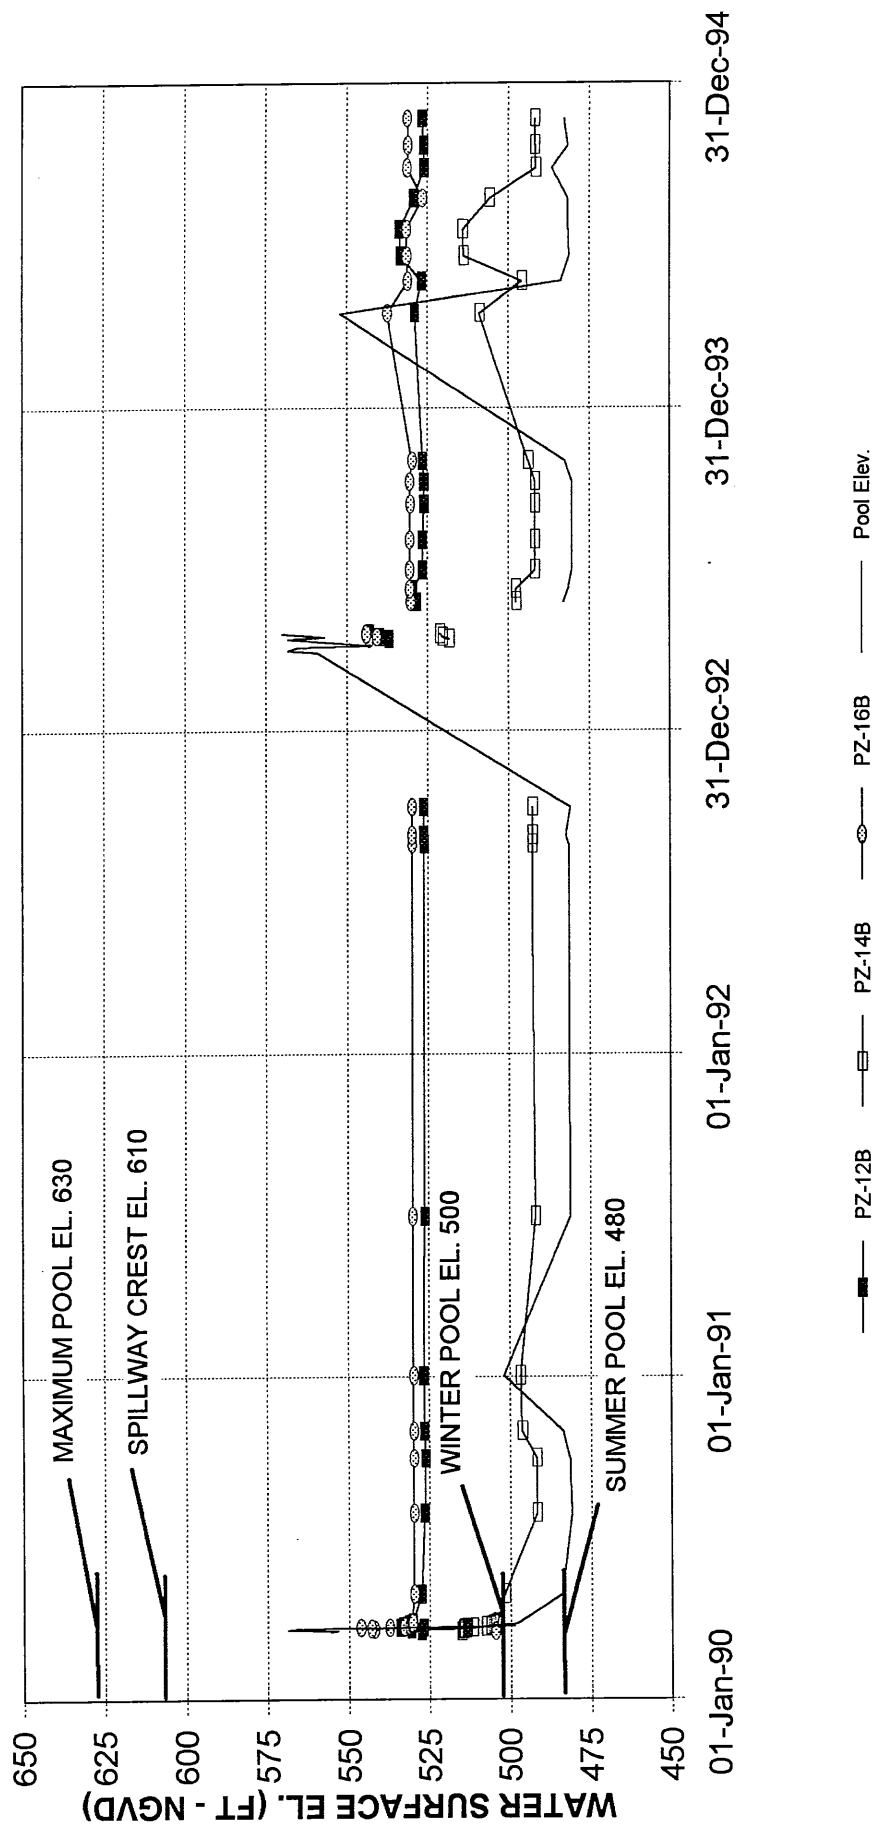
FIGURE 22

Based on the March 1990 flood event shown in Figure 22, the following performance was noted. Measurements for 22 and 23 March show an unusual drop in the piezometric level. These readings were not used in the following analysis. The water level in PZ-12B rose from its average level about 4 ft. to El. 534.2 compared to a pool increase of 69 ft. to El. 568.8. The pool data available for the March 1990 event indicates a peak pool level on 21 March and a falling pool through 29 March. PZ-12B water levels fell from a peak level on 24 March to lower levels through 29 March. The peak water level at PZ-12B apparently occurred on 24 March; therefore, it appears the response time is about three days.

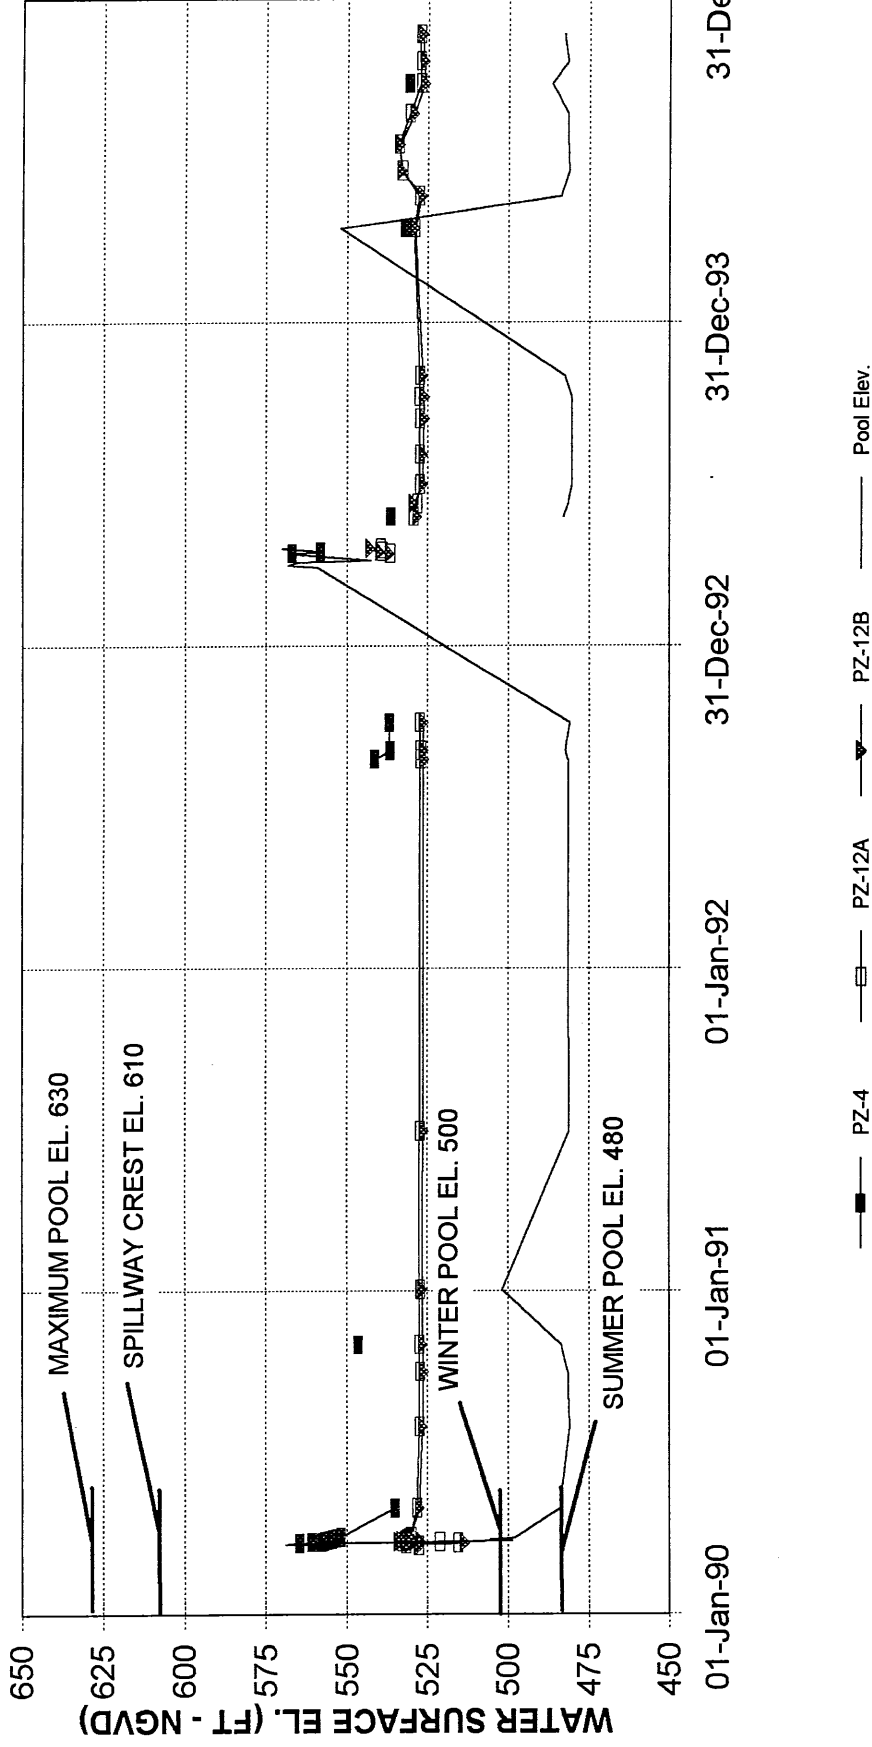
Although PZ-4 appears to be plugged, the piezometer did show response to the high pool in March 1990. Based on the March 1990 flood event shown in Figure 23, the following performance was noted. The water level in PZ-4 rose from its average level about 10 ft. to El. 564.6 compared to a pool increase of 69 ft. to El. 568.8. The pool data available for the March 1990 event indicates a peak pool level on 21 March and a falling pool through 29 March. PZ-4 water levels fell from a high level on 22 March to lower levels through 29 March. No data is available before 22 March for PZ-4; therefore, the high water level on 22 March may not represent a peak level. However, after the peak pool level, the pool and piezometer levels dropped at the similar times, indicating that the piezometer response time was about one day or less. However, PZ-4 water levels dropped at a very slow rate relative to the rate of decrease of the pool level, probably due to the plugged piezometer tip.

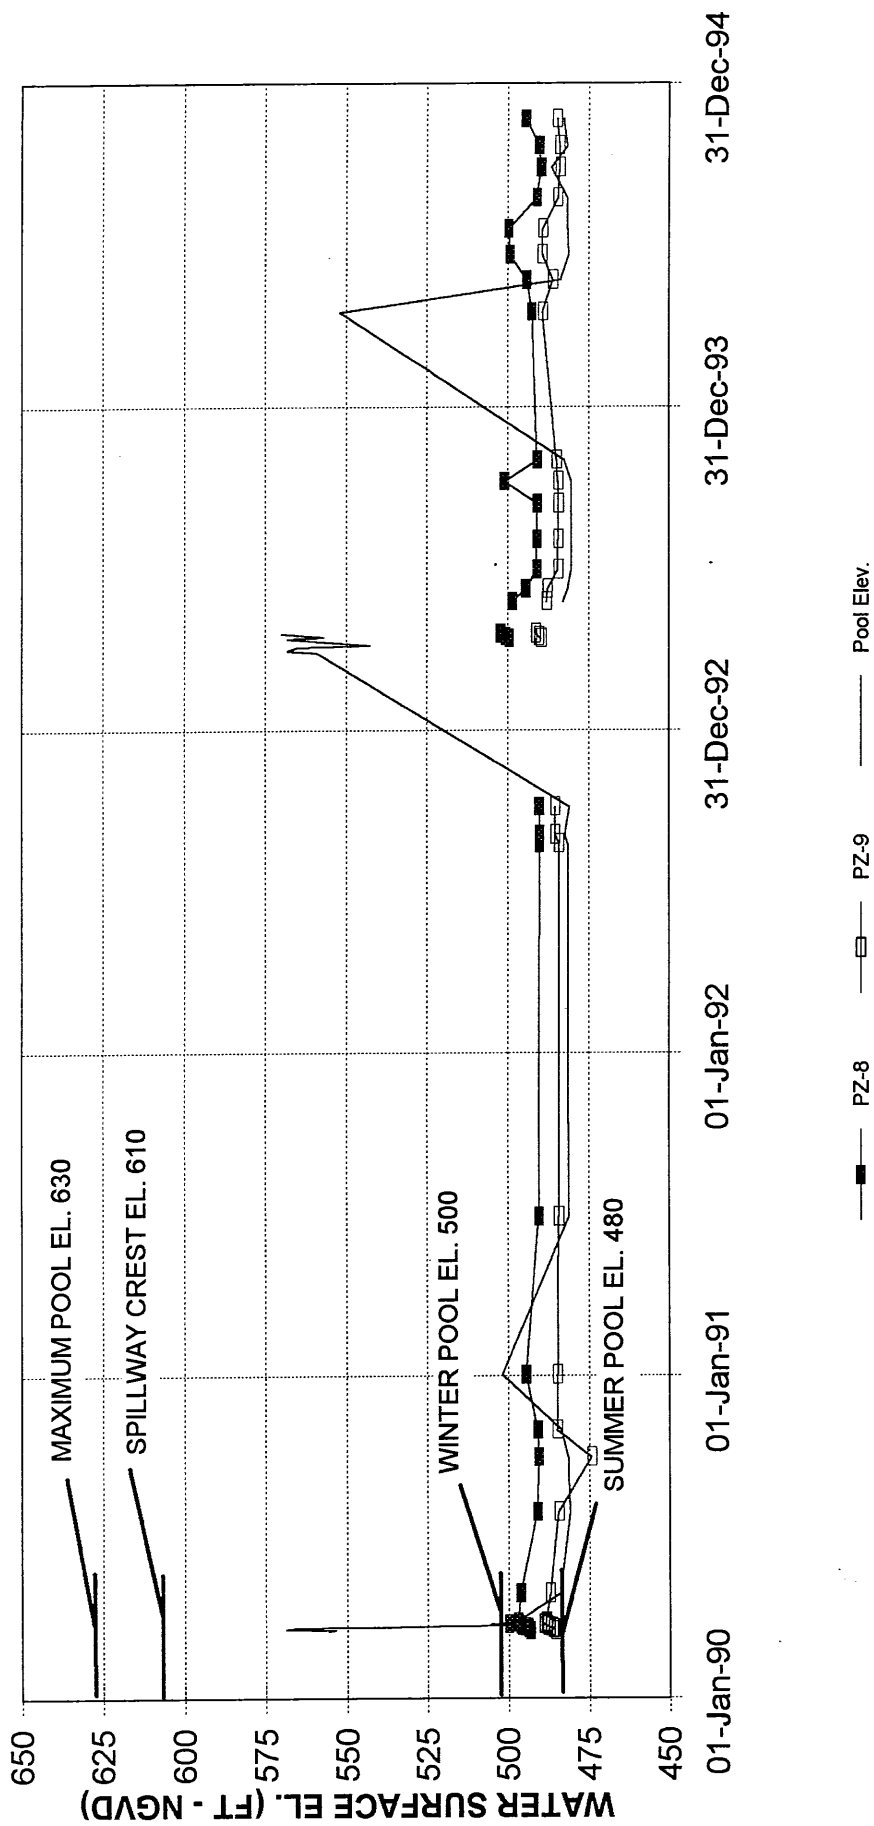
FIGURE 24

Based on the March 1990 flood event shown in Figure 24, the following performance was noted. The water level in PZ-8 rose from its average level about 4 ft. to El. 500.0 compared to a pool increase of about 69 ft. to El. 568.8. The pool data available for the March 1990 event indicates a peak pool level on 21 March and a falling pool through 29 March. PZ-8 water levels rose to a peak level on 27 March and fell to lower levels through 29 March. The peak water level at PZ-8 apparently occurred on 27 March indicating a response time of about six days.

Based on the March 1990 flood event shown in Figure 24, the following performance was noted. The water level in PZ-9 rose from its average level about 2 ft. to El. 489.1 compared to a pool increase of about 69 ft. to El. 568.8. The pool data available for the March 1990 event indicates a peak pool level on 21 March and a falling pool through 29 March. PZ-9 water levels rose to a peak level on 27 March and fell to lower levels through 29 March. The peak water level at PZ-9 apparently occurred on 27 March, indicating a response time of about six days.

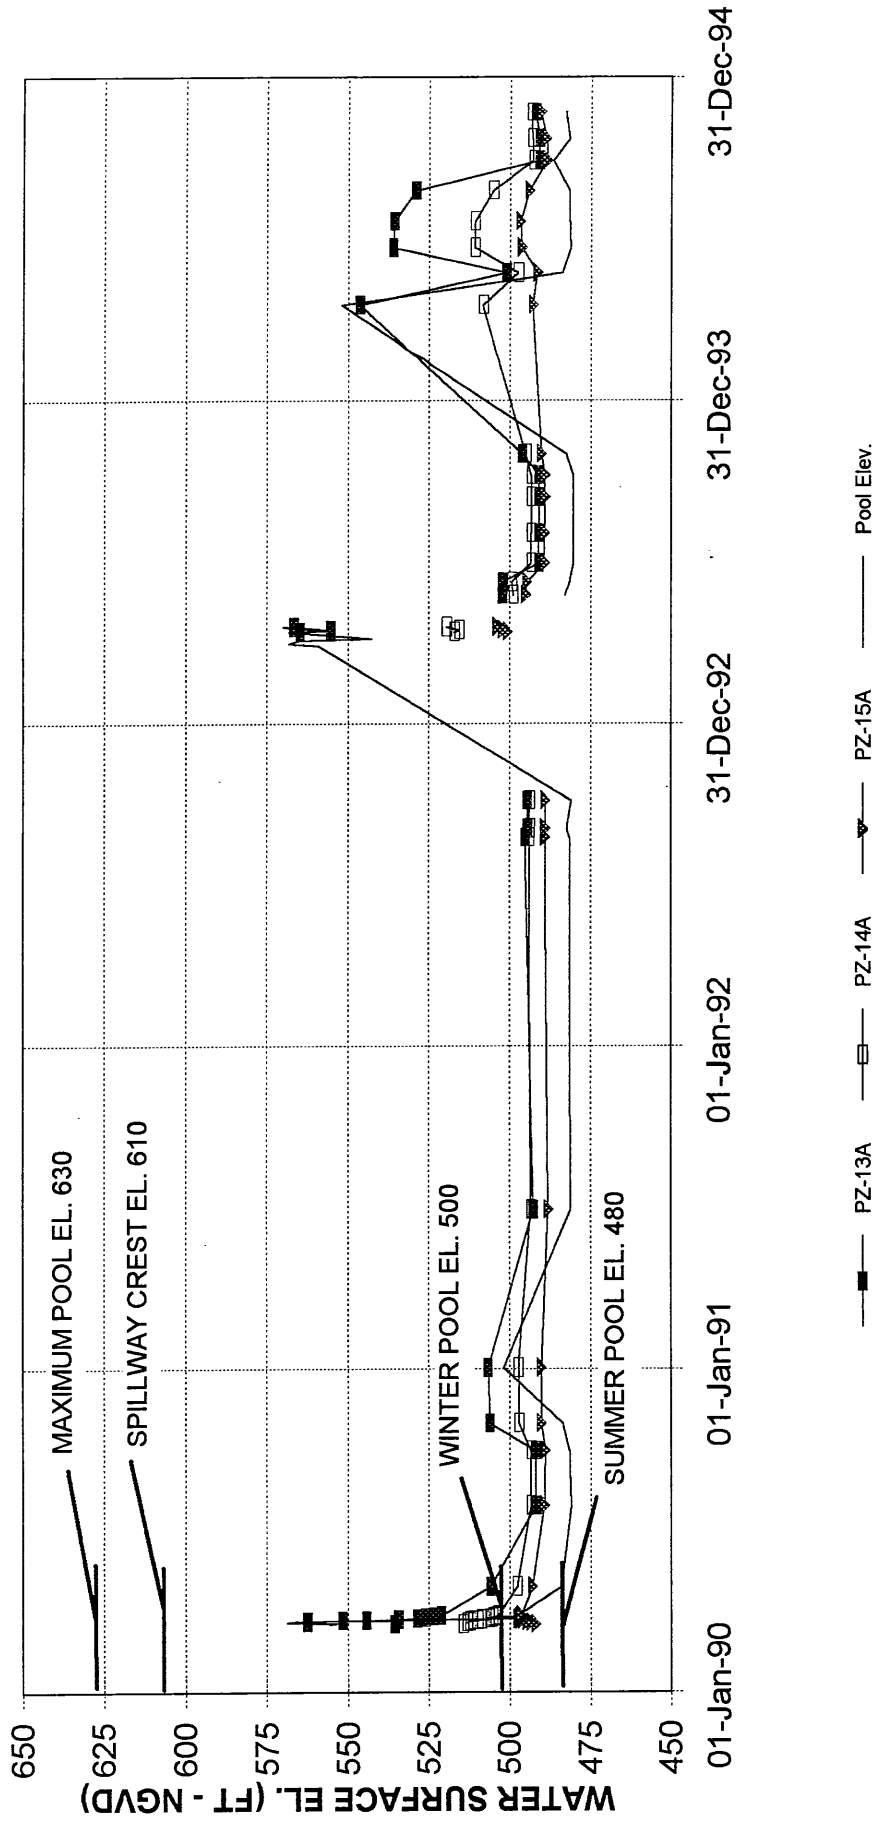
Based on the March 1990 flood event shown in Figure 25, the following performance was noted. The water level in PZ-13A rose from its average level about 43 ft. to El. 562.6 compared to a pool increase of about 69 ft. to El. 568.8. The pool data available for the March 1990 event indicates a peak pool level on 21 March and a falling pool through 29 March. PZ-13A water levels fell from a peak level on 22 March to lower levels through 29 March. The peak water level at PZ-13A apparently occurred on 22 March; therefore, it appears the response time is about one day.

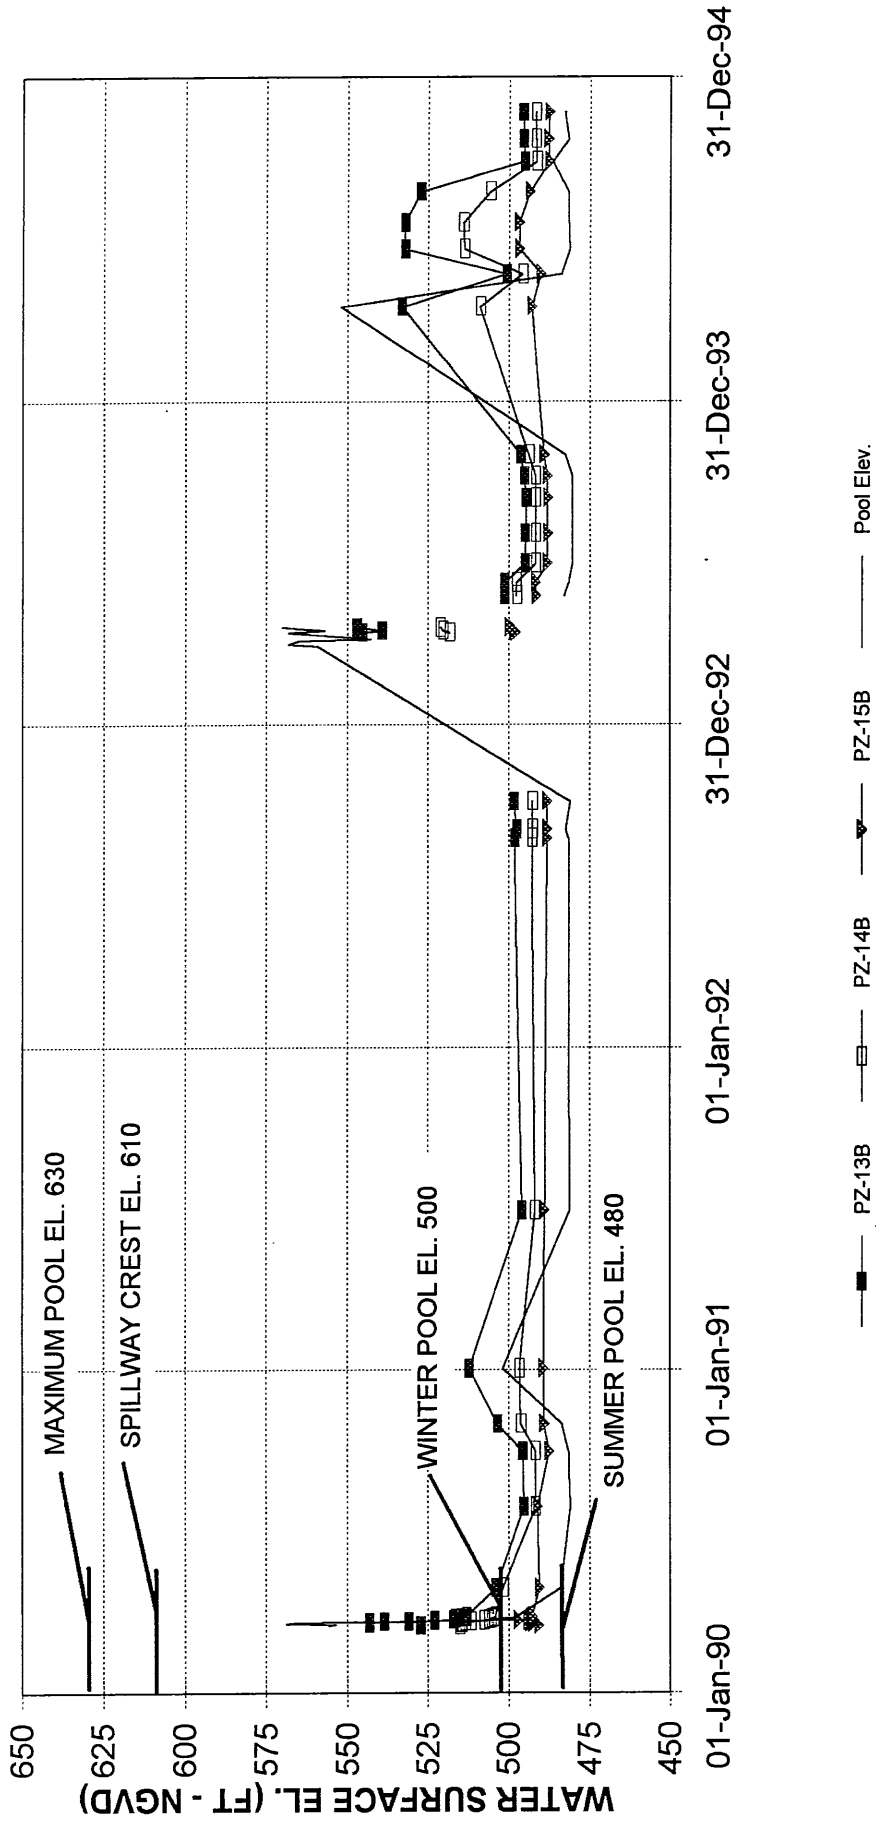
Based on the March 1990 flood event shown in Figure 26, the following performance was noted. The water level in PZ-13B rose from its average level about 28 ft. to El. 543.2 compared to a pool increase of about 69 ft. to El. 568.8. The pool data available for the March 1990 event indicates a peak pool level on 21 March and a falling pool through 29 March. PZ-13B water levels fell from a
